# Coolidge Municipal Airport

## Pavement Management Report

# COOLIDGE MUNICIPAL AIRPORT PAVEMENT MANAGEMENT REPORT

**November 2017**

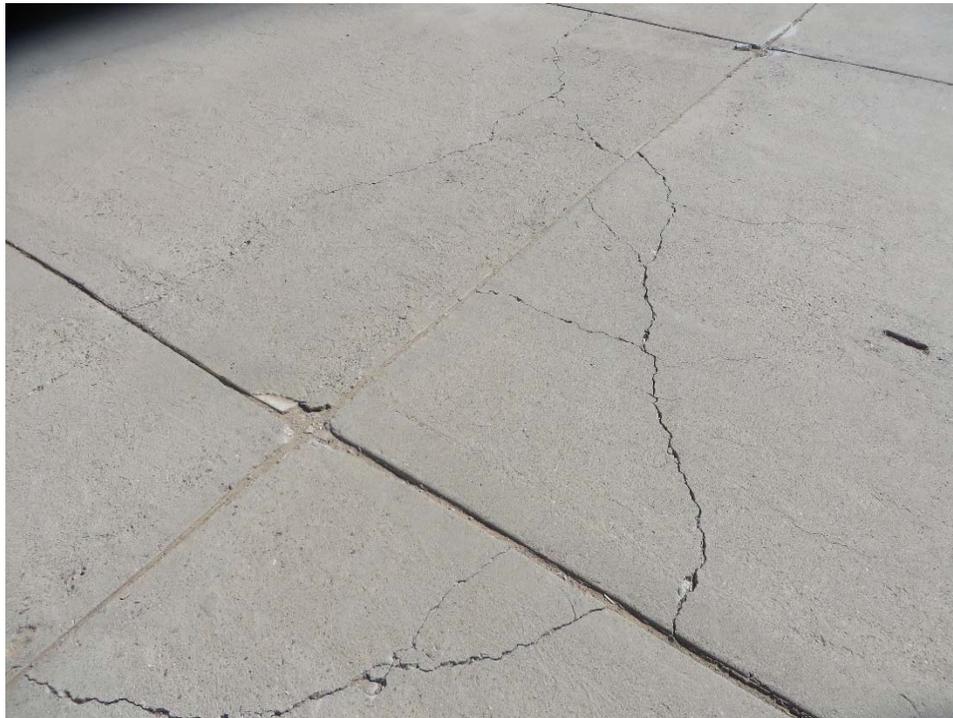
A01CM-10. Corner Break (Sample Unit No. 25).

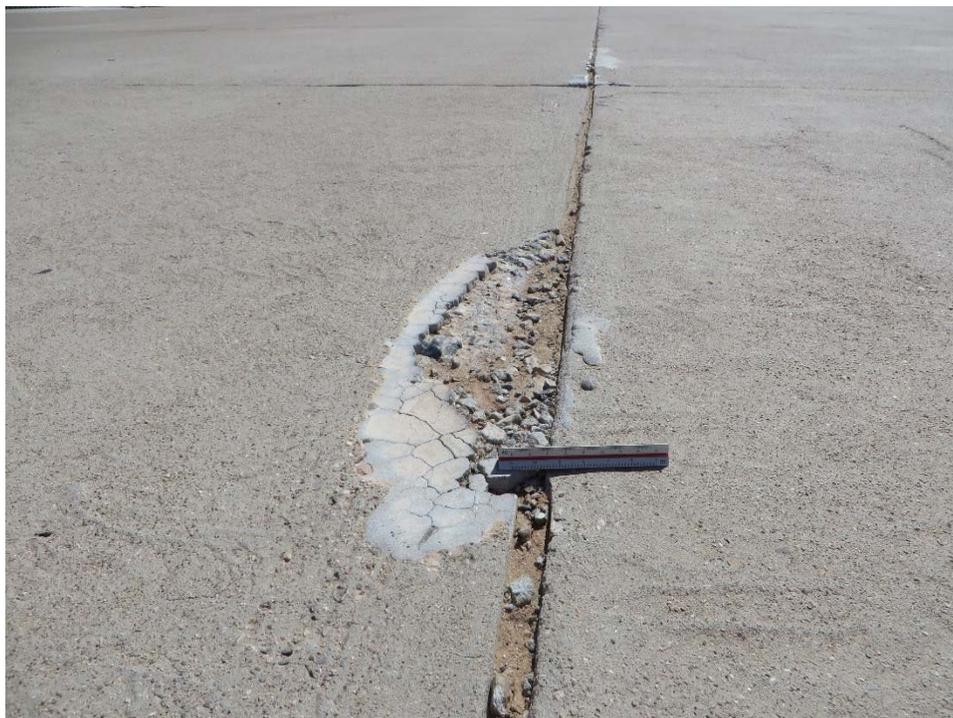
A01CM-10. Joint Spalling (Sample Unit No. 09).

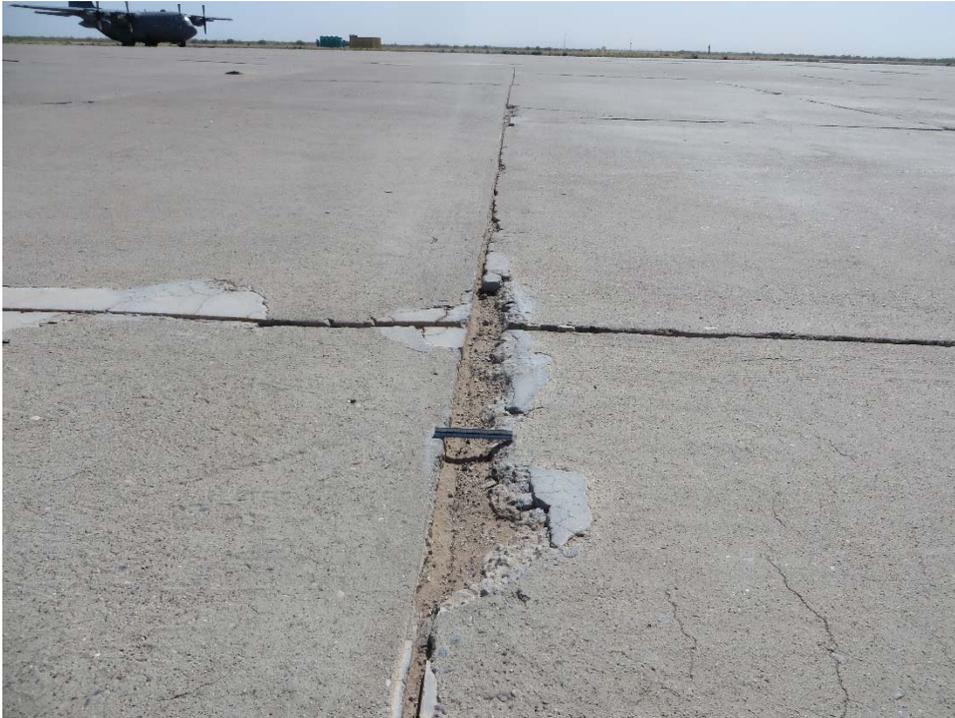
A01CM-10. Joint Spalling (Sample Unit No. 25).

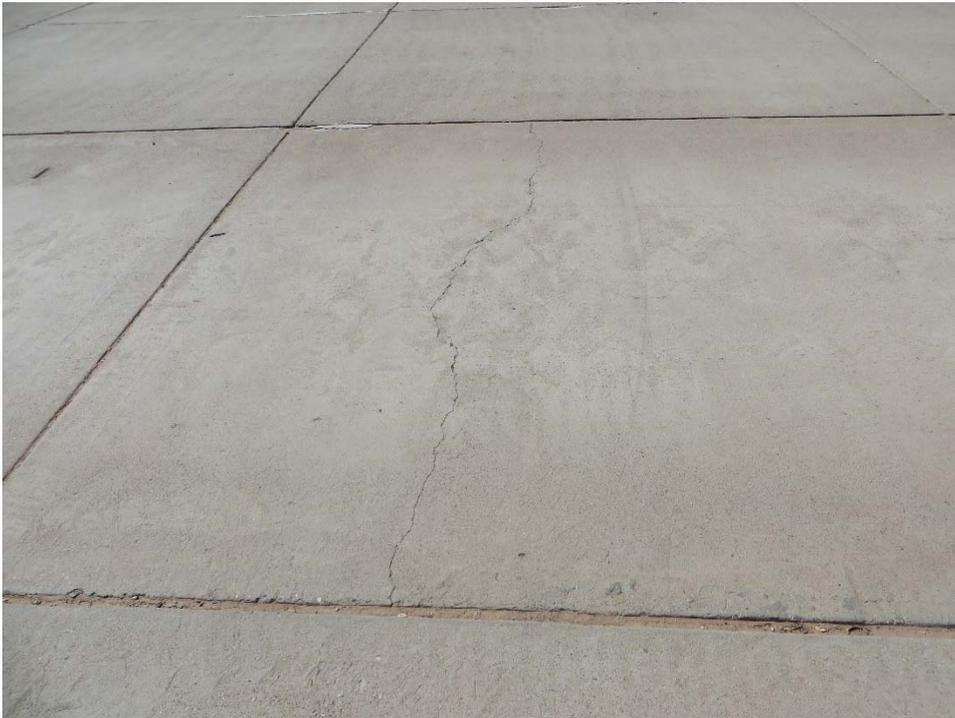
A01CM-10. LTD Cracking (Sample Unit No. 09).

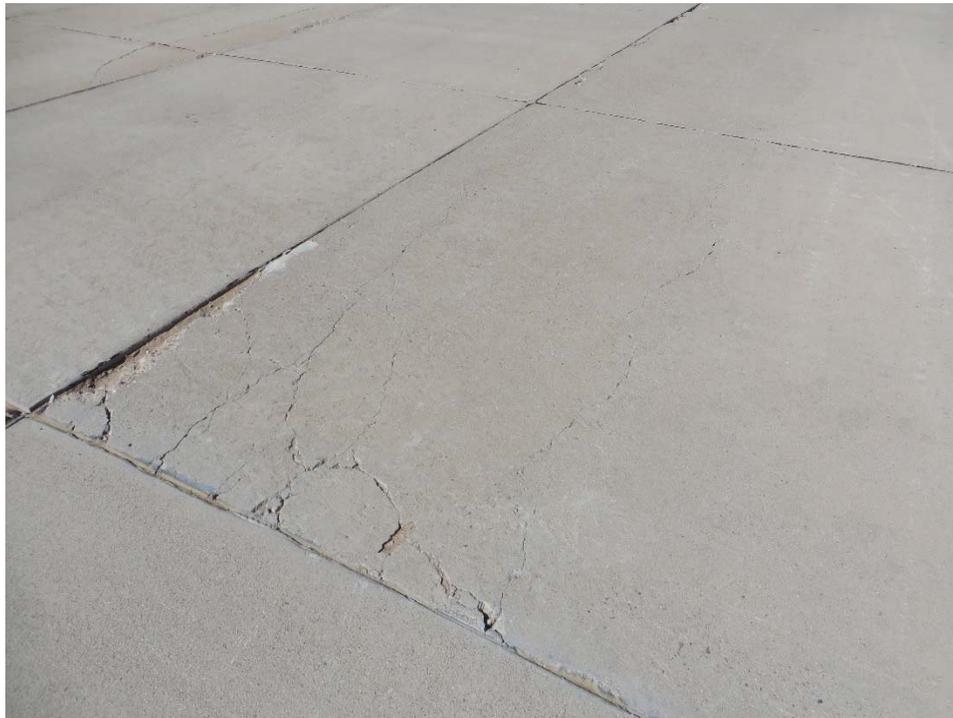
A01CM-10. Shattered Slab (Sample Unit No. 24).

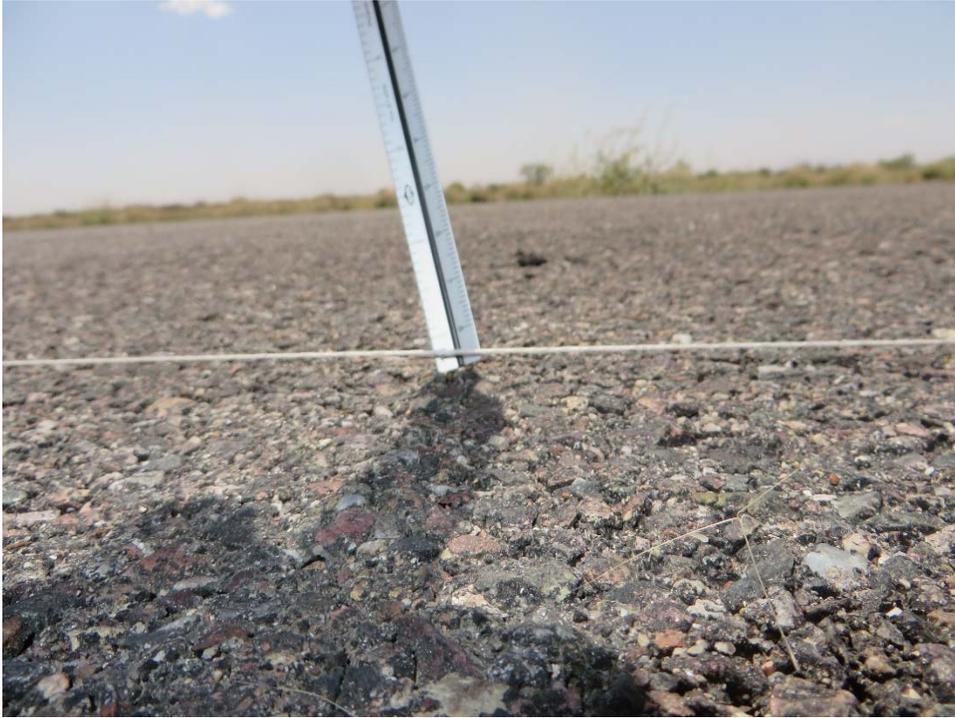
RW1735CM-10. Depression (Sample Unit No. 33).

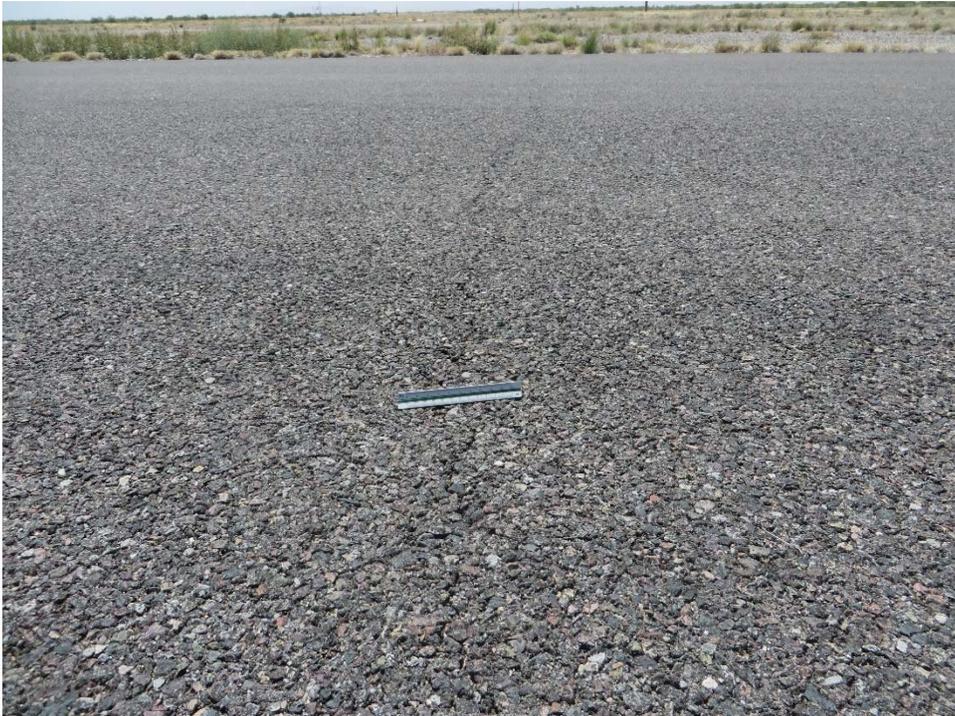
RW1735CM-10. L&T Cracking (Sample Unit No. 11).

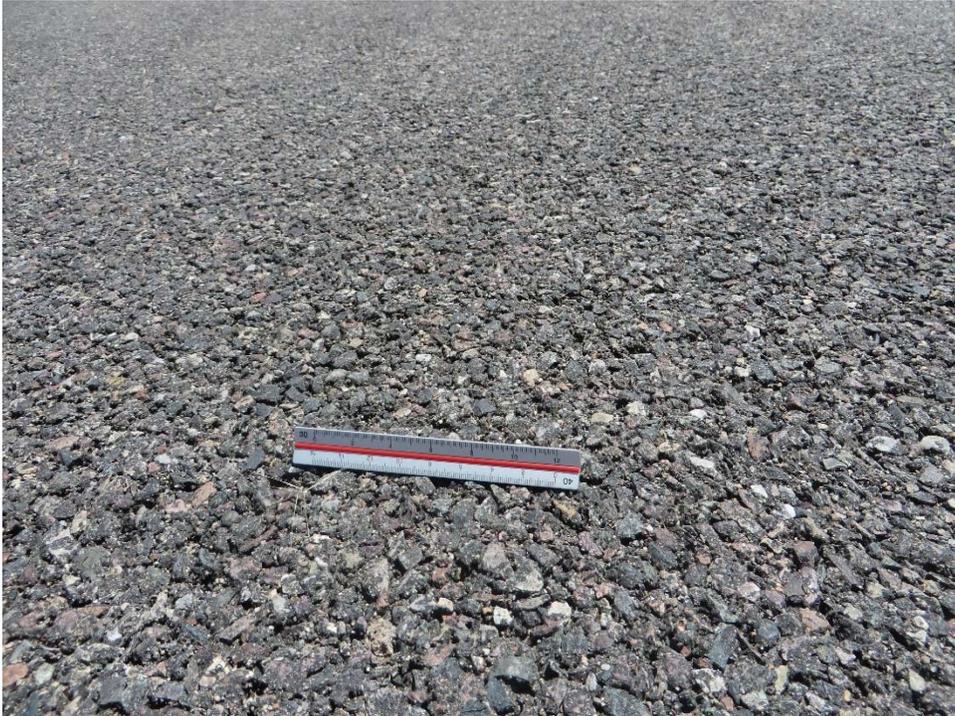
RW1735CM-10. Raveling (Sample Unit No. 25).

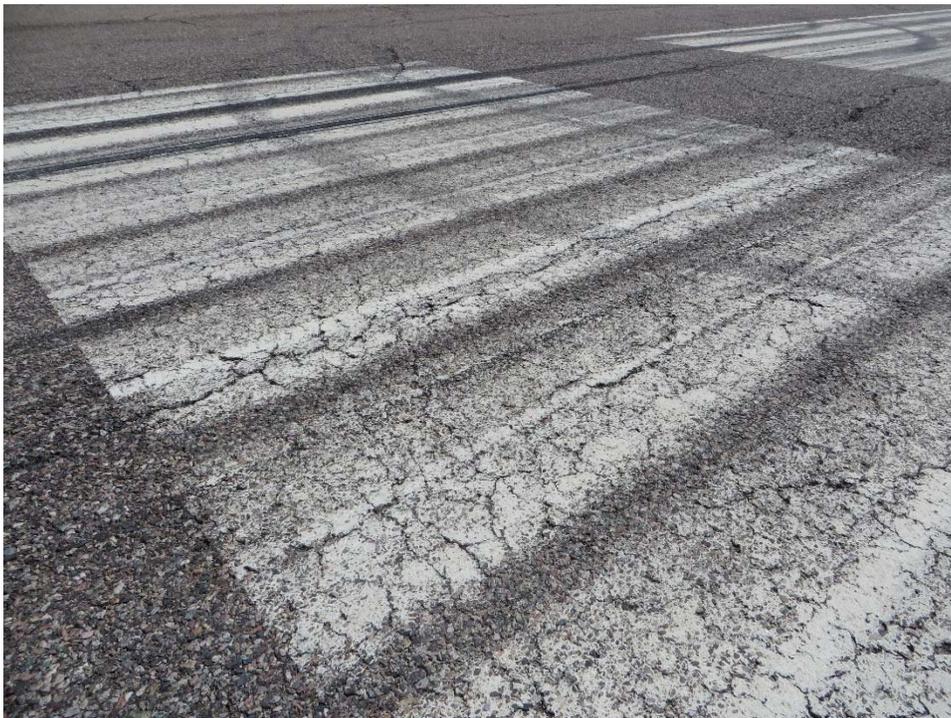
RW523CM-10C. Paint Unsatisfactory.

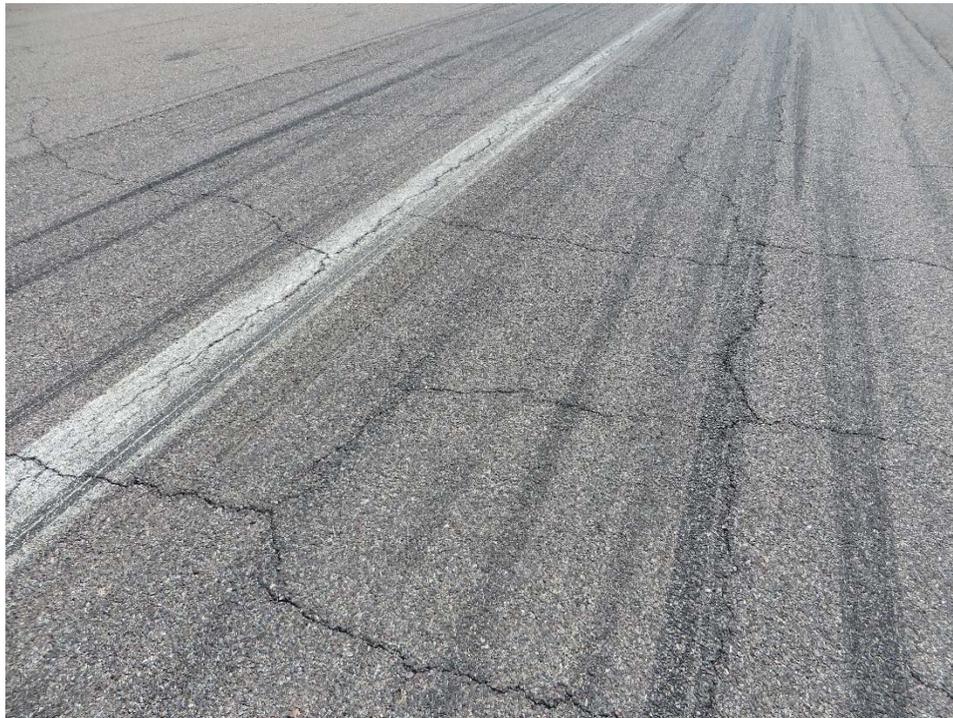
RW523CM-10C. Block Cracking (Sample Unit No. 65).

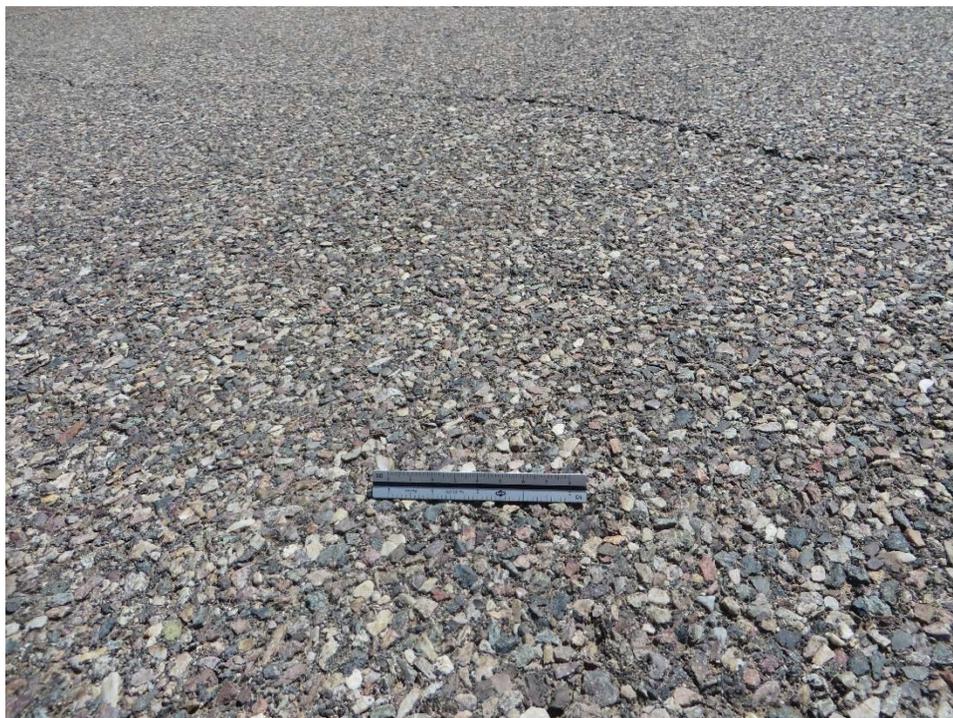
RW523CM-10C. Raveling (Sample Unit No. 65).

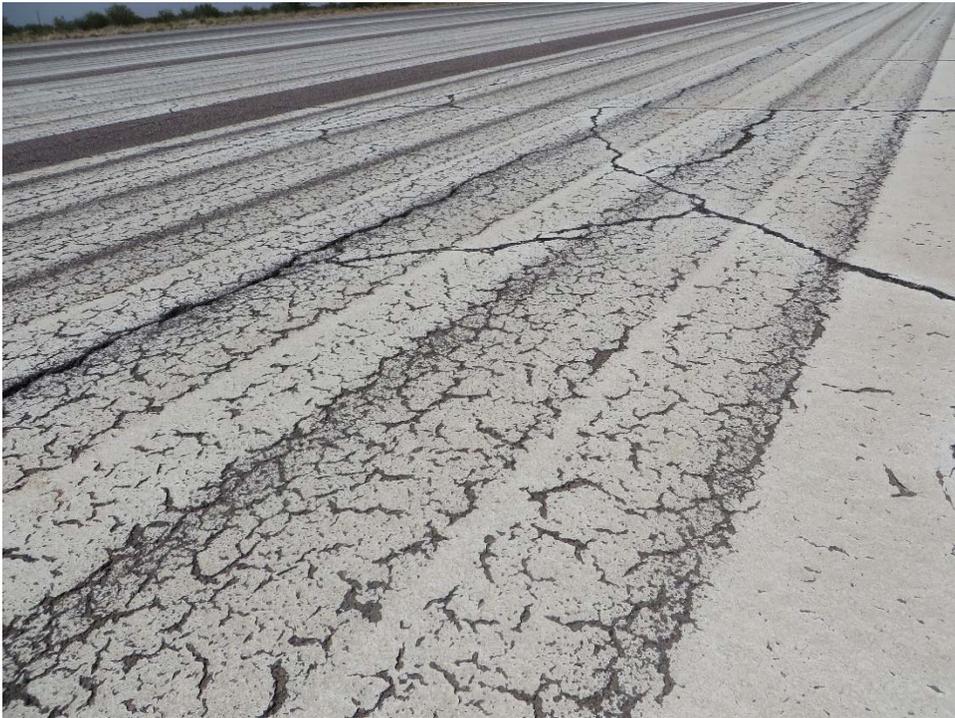
RW523CM-10NS. Paint Unsatisfactory.

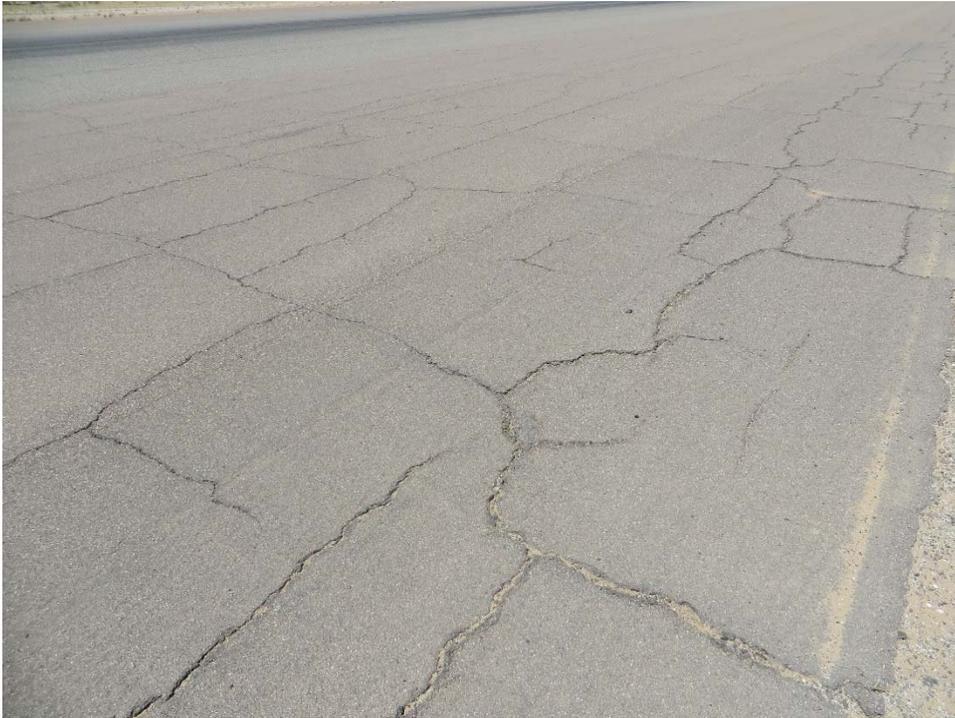
RW523CM-10NS. Block Cracking (Sample Unit No. 65).

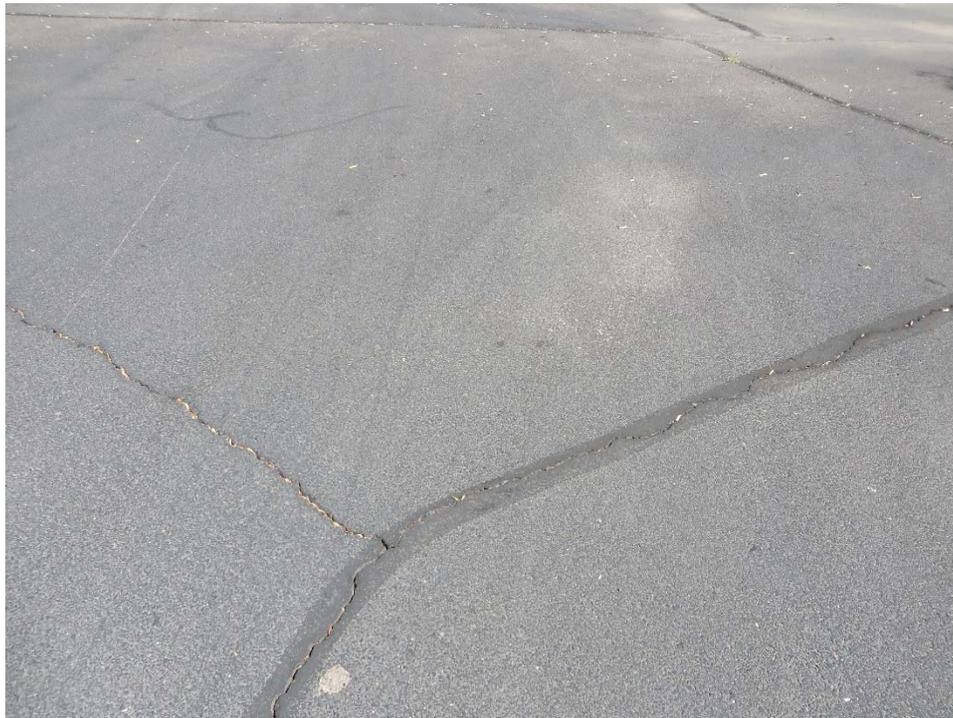
TH01CM-10. L&T Cracking (Sample Unit No. 01).

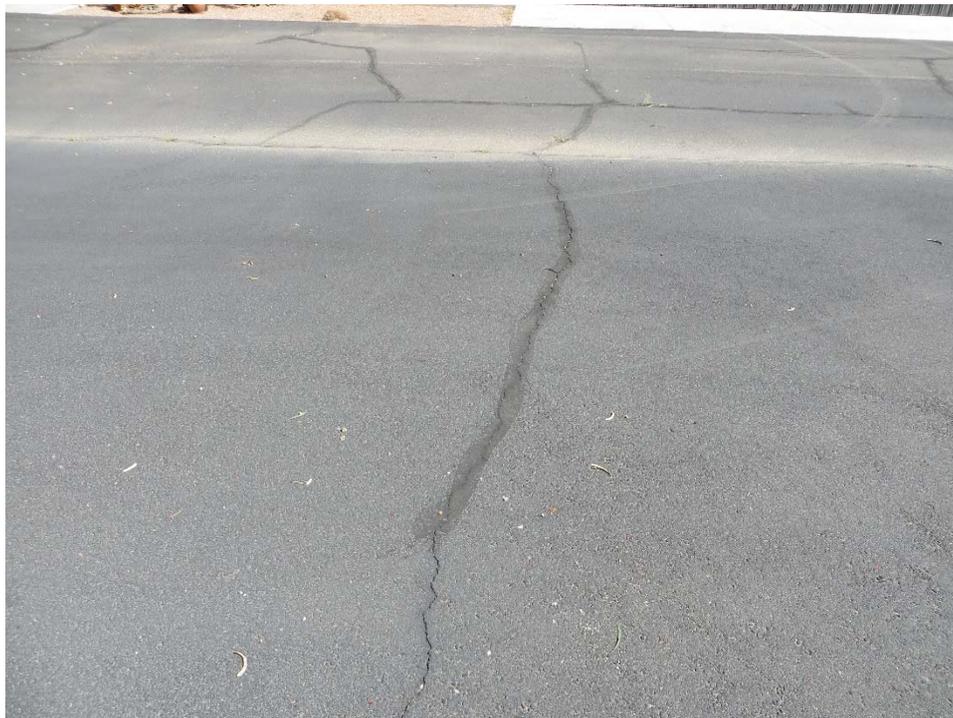
TH01CM-10. L&T Cracking (Sample Unit No. 04).

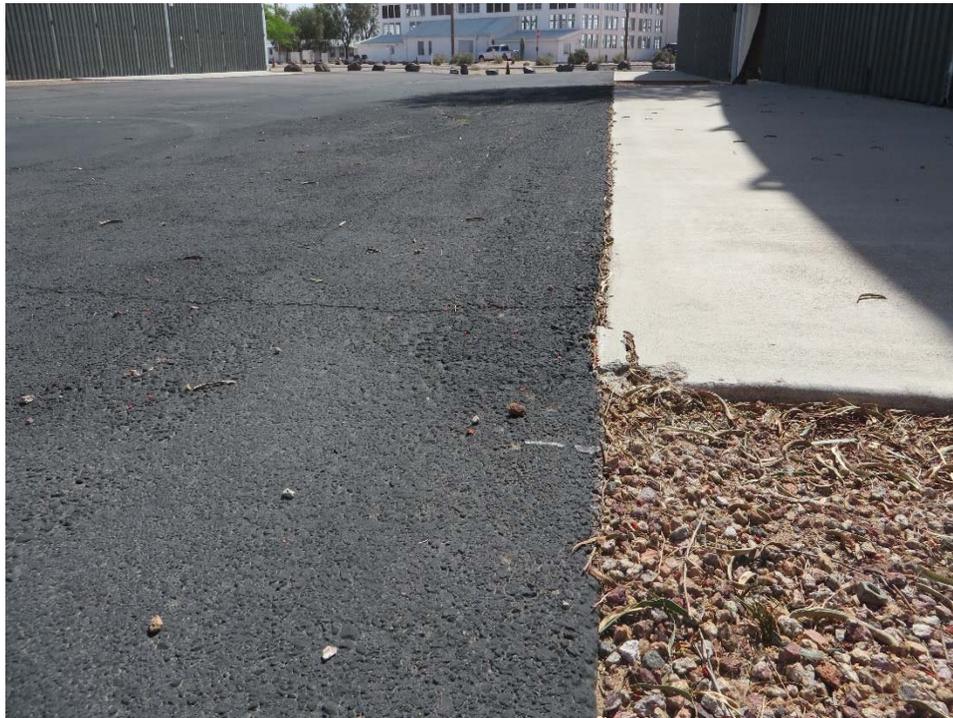
TH01CM-10. Shoving (Sample Unit No. 04).

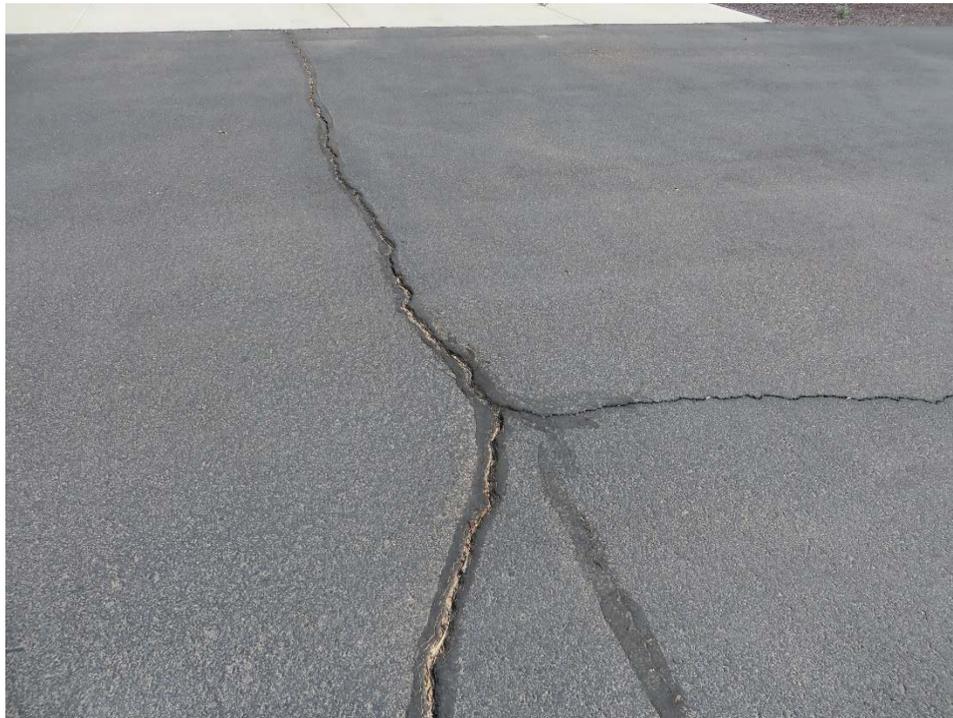
TH01CM-20. L&T Cracking (Sample Unit No. 02).

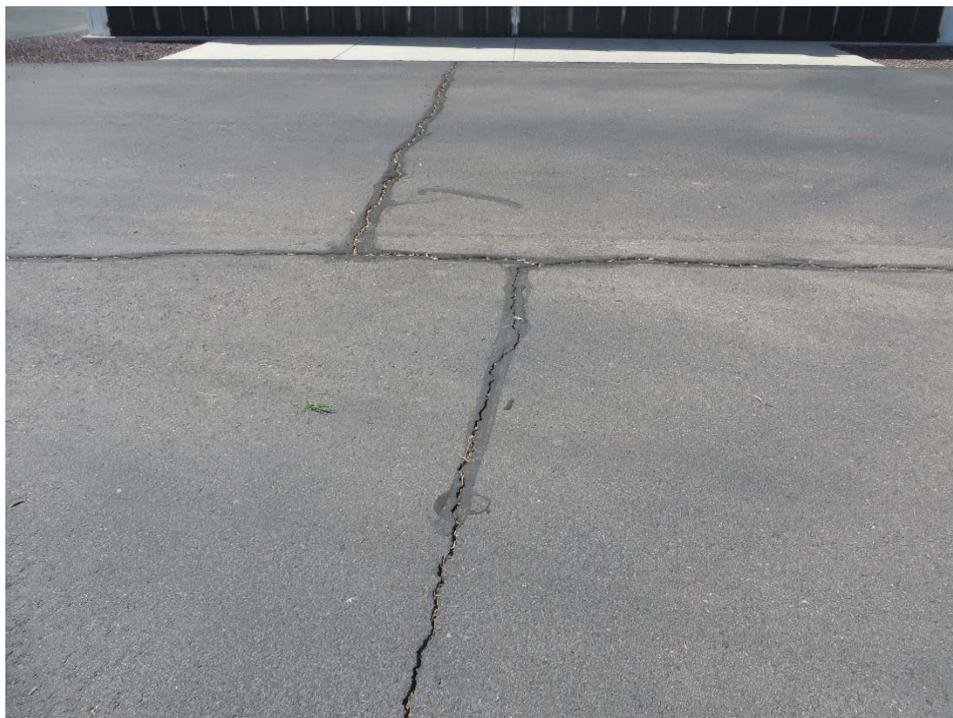
TH01CM-20. L&T Cracking (Sample Unit No. 05).

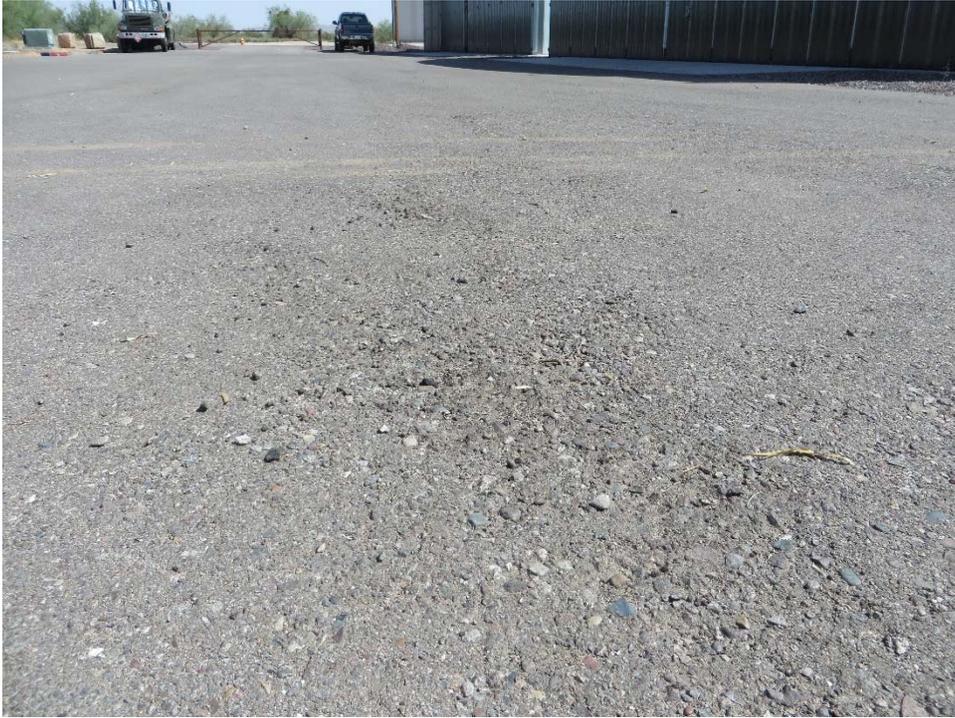
TH01CM-30. Raveling (Sample Unit No. 01).

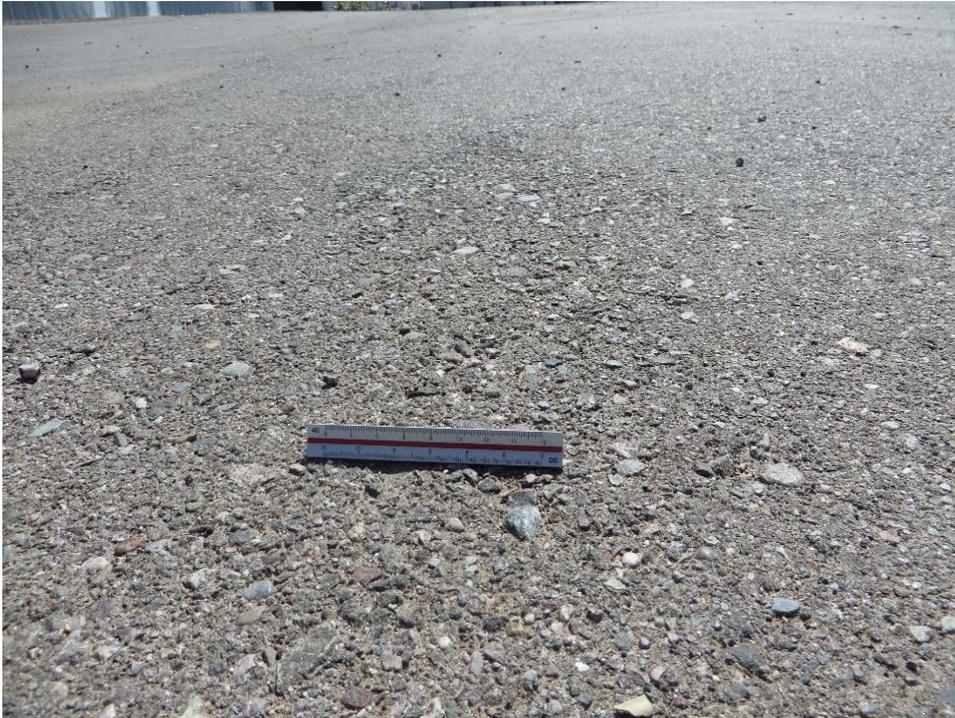
TH01CM-30. Weathering (Sample Unit No. 01).

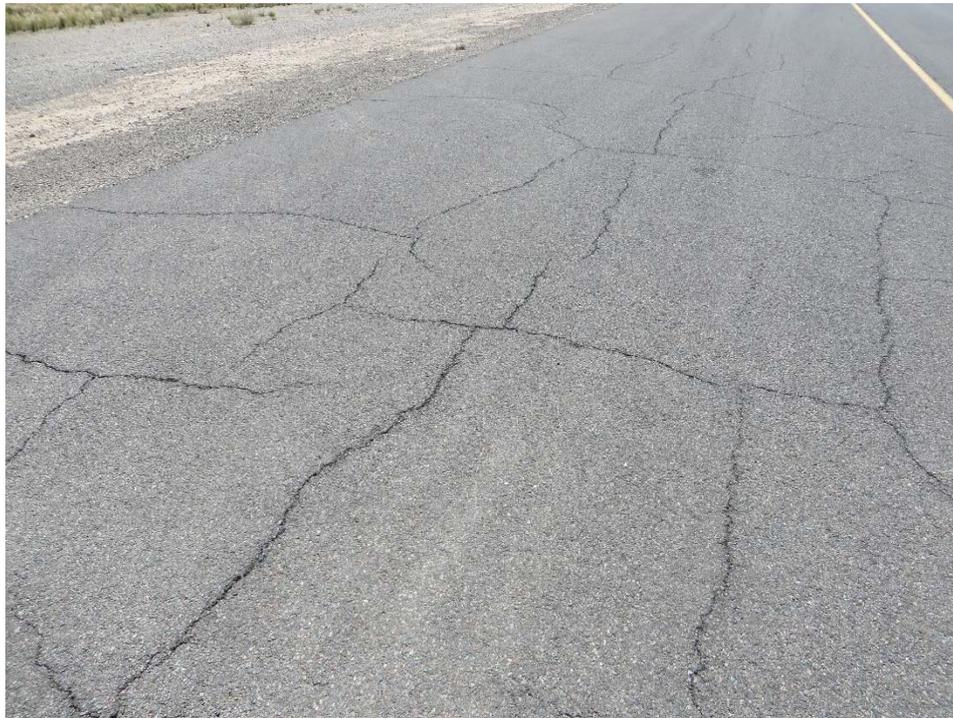
TWACM-10. Block Cracking (Sample Unit No. 34).

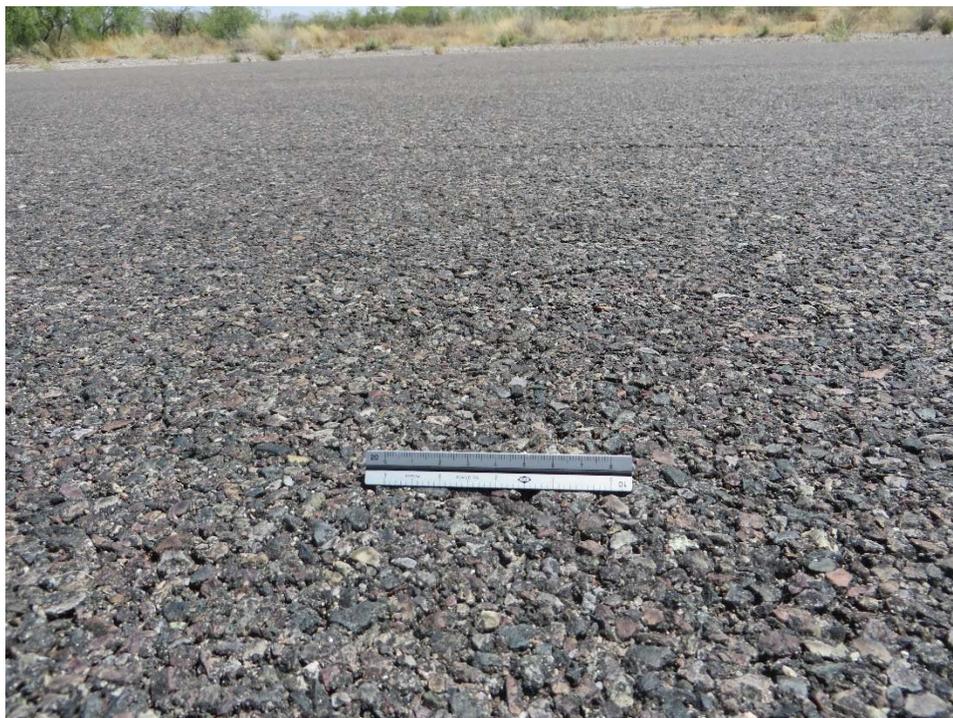
TWACM-10. Raveling (Sample Unit No. 23).

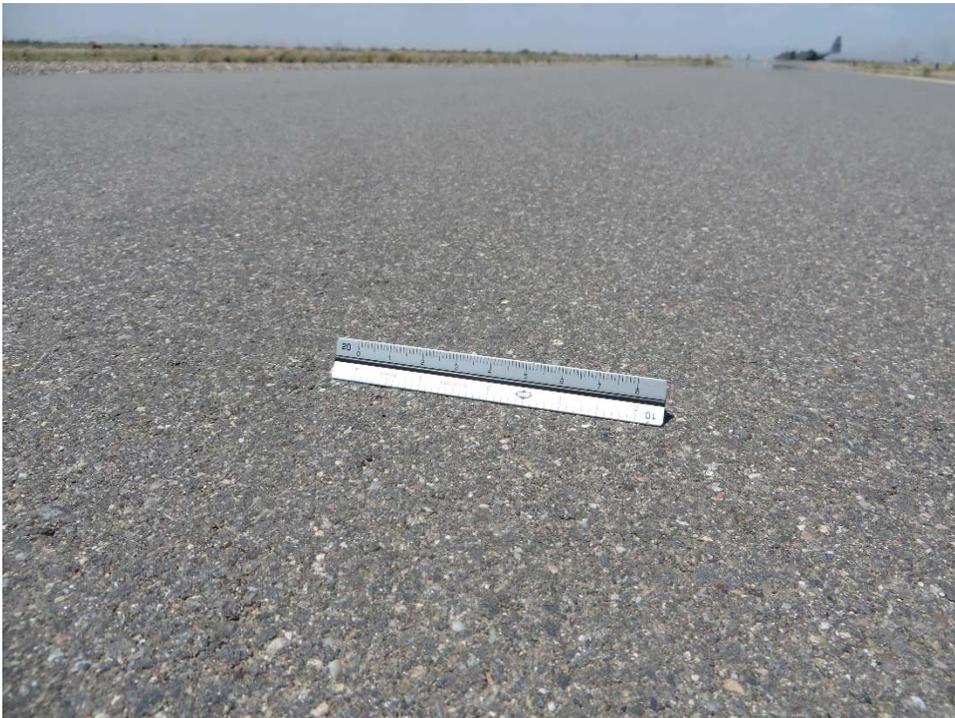
TWACM-20. Weathering (Sample Unit No. 20).

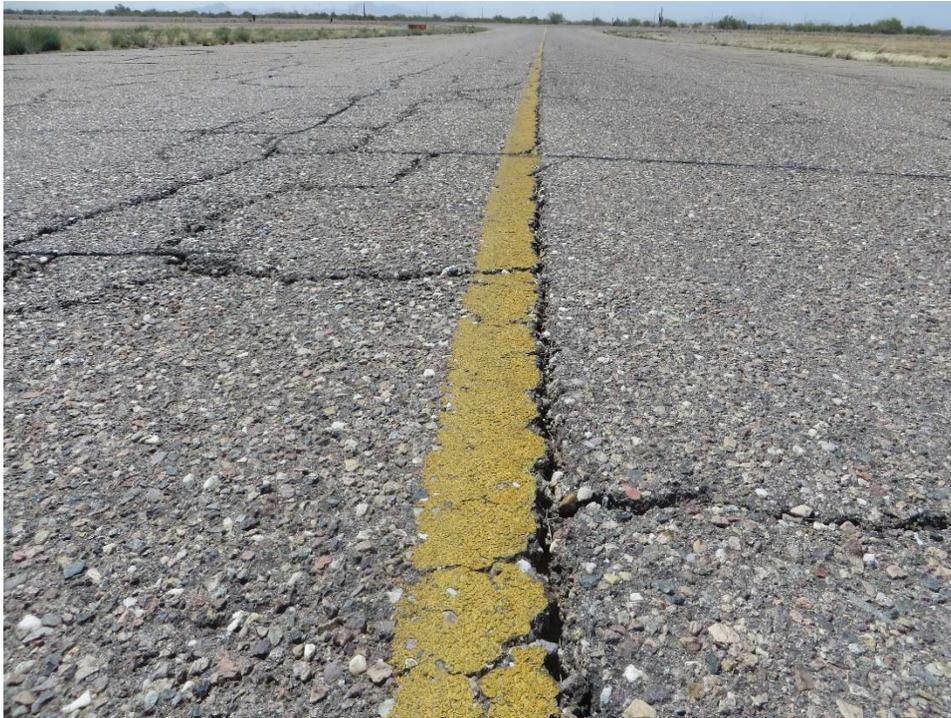
TWBCM-10. Paint Unsatisfactory.

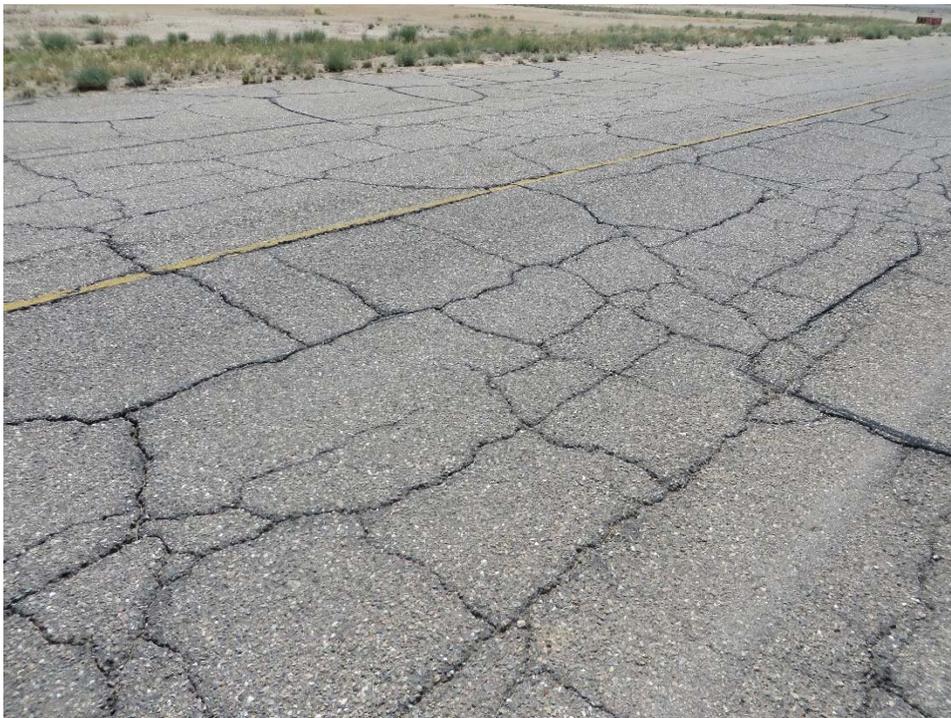
TWBCM-10. Block Cracking (Sample Unit No. 05).

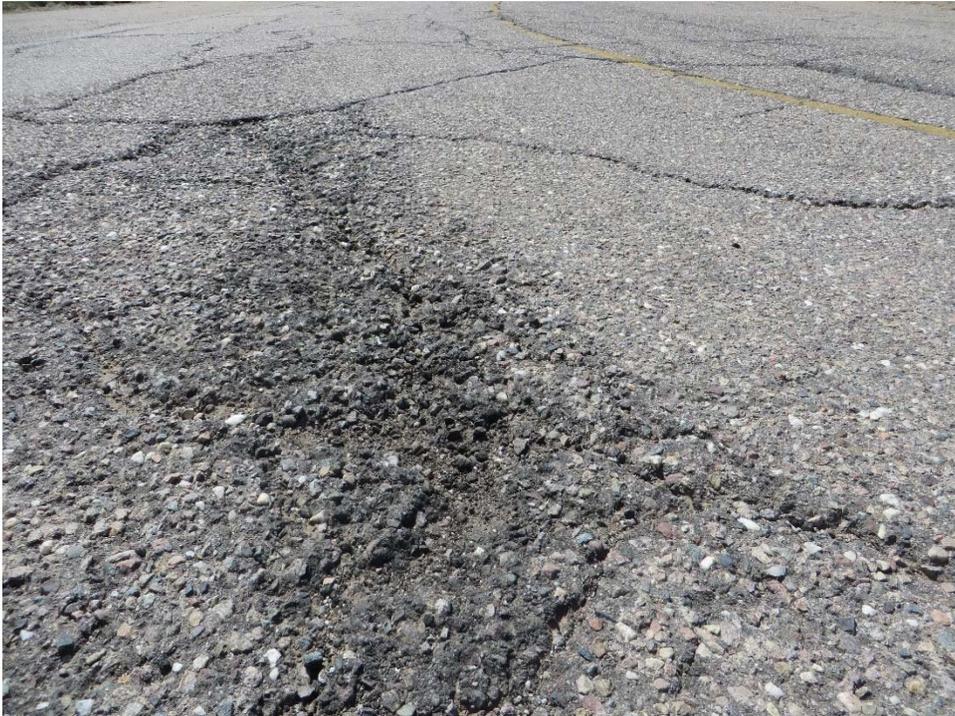
TWBCM-10. Raveling (Sample Unit No. 06).

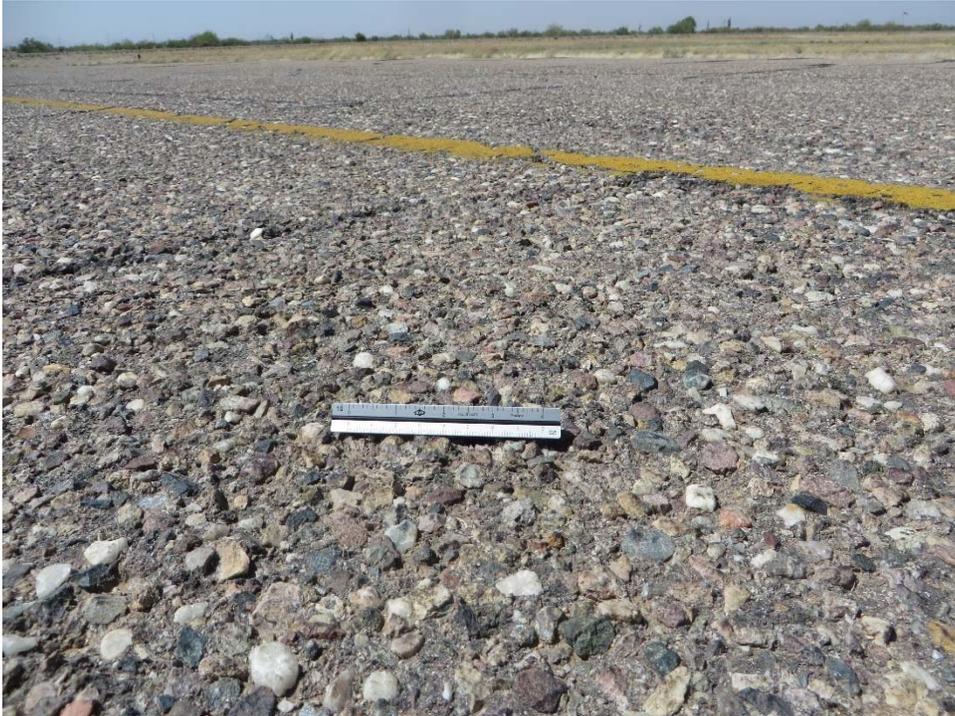
TWBCM-10. Weathering (Sample Unit No. 05).
